Seismic Characterization of Wind Turbine Sites Near Lawton, Oklahoma, by the MASW Method

APPENDIX III: Maps from Surface-Wave Imaging by Attenuation (SIA)

Open-file Report 2005-22 (part 4 of 4)

Blue Canyon Wind Mill Farm Phase II (Turbine Tower Locations: T-201 — T-284)

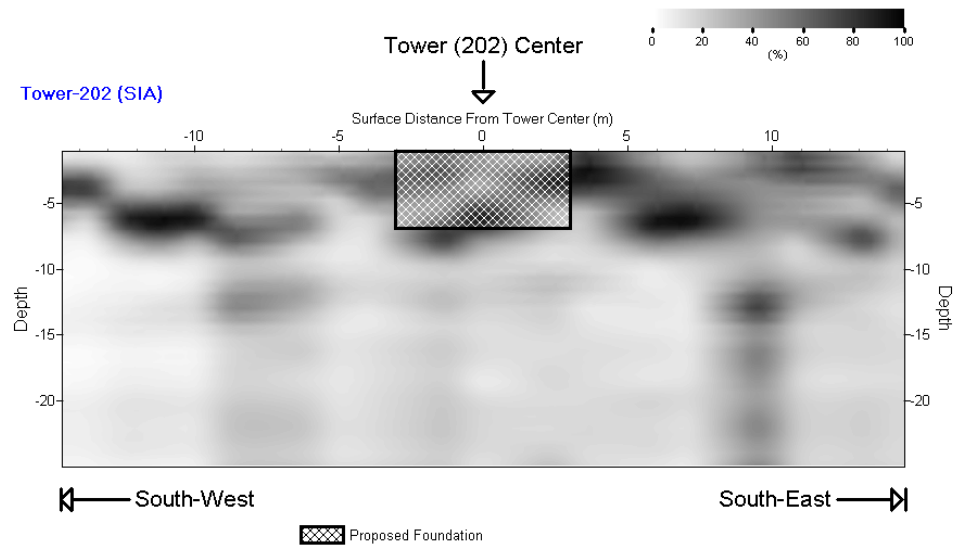
T-202

**A shorter receiver spacing of 2 ft was used due to terrain condition (steep drop off).

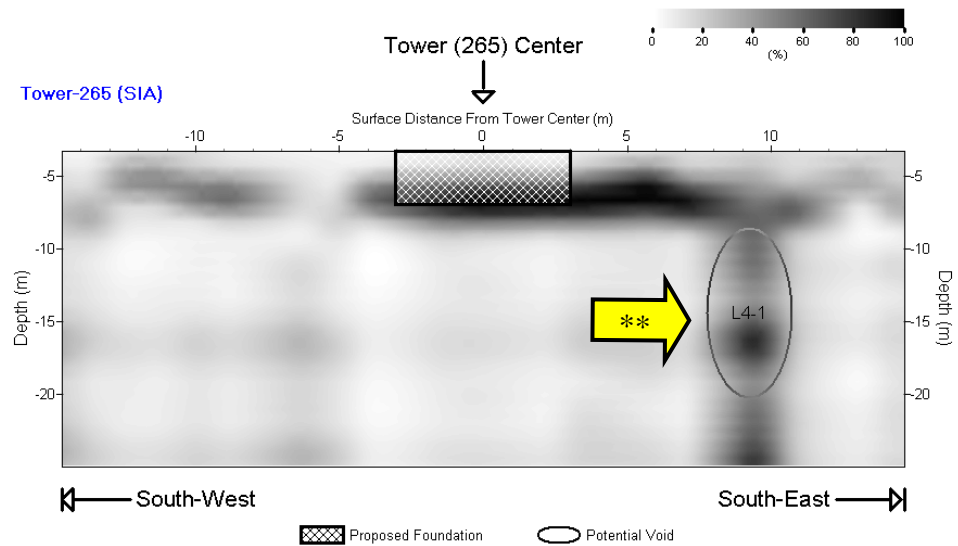
T-265

*Data not acquired due to terrain condition **Potential void (see separate text file for coordinates)
