APPENDICES

“Seismic Characterization of Wind Turbine Sites in Kansas by the MASW Method”

Elk River 10 Selected Sites

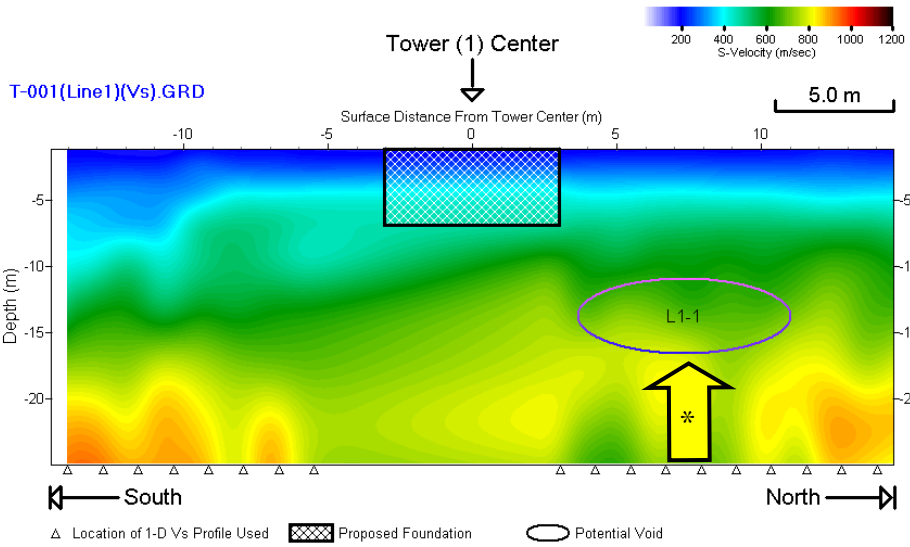
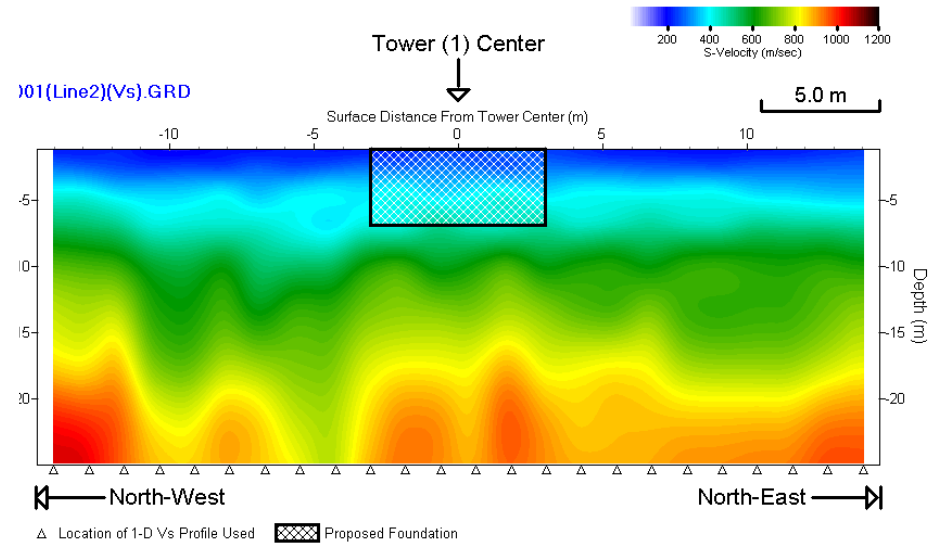
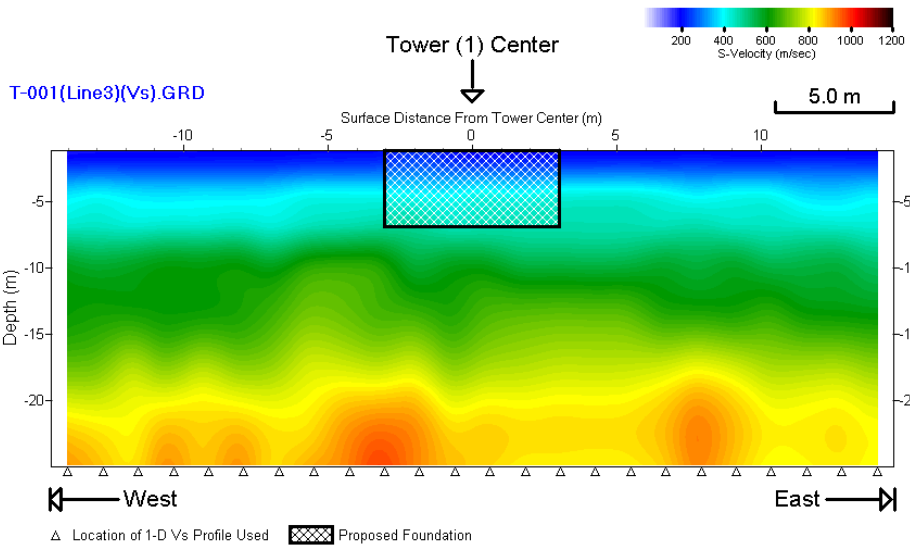
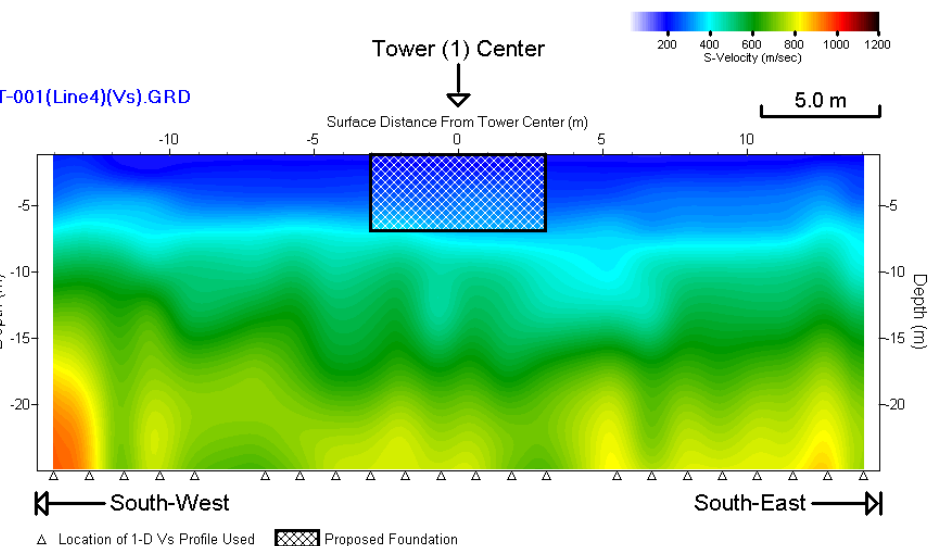
T-001

*Potential void or anomaly (see separate text file for coordinates)

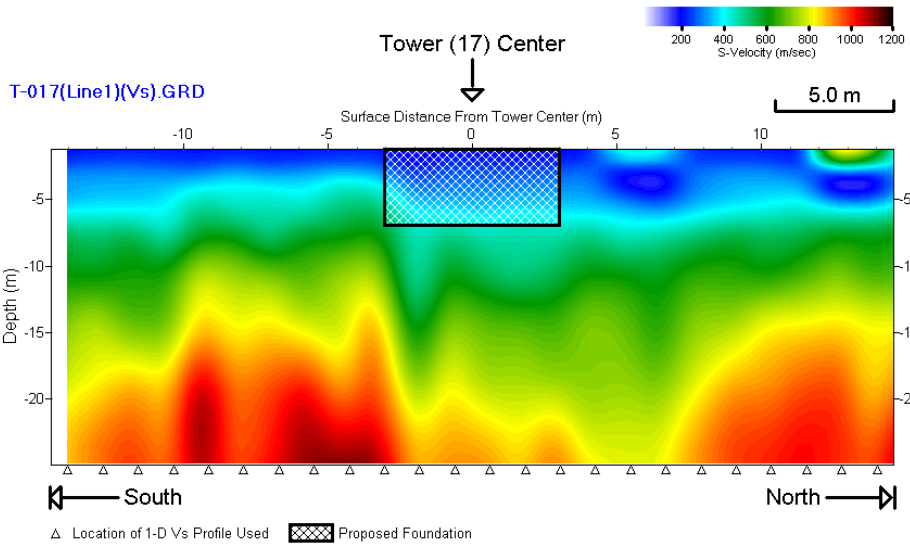
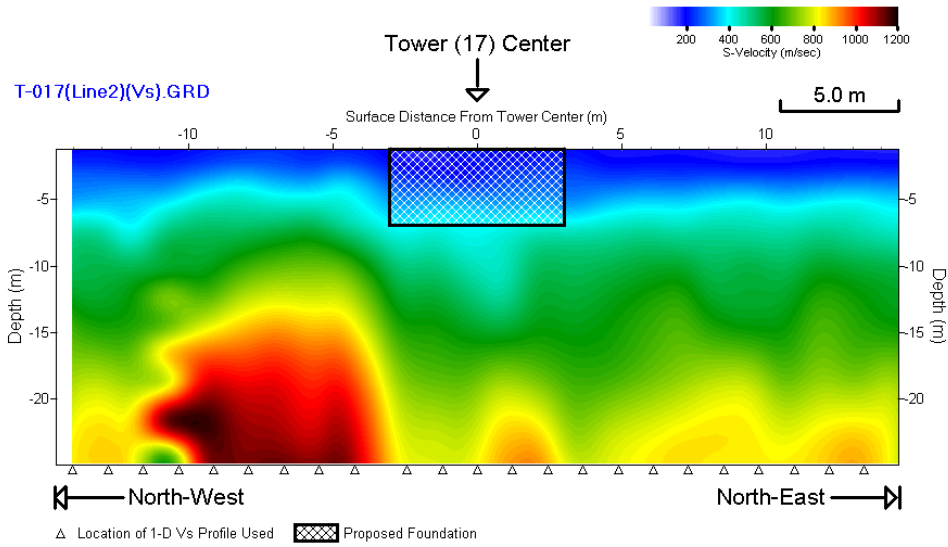
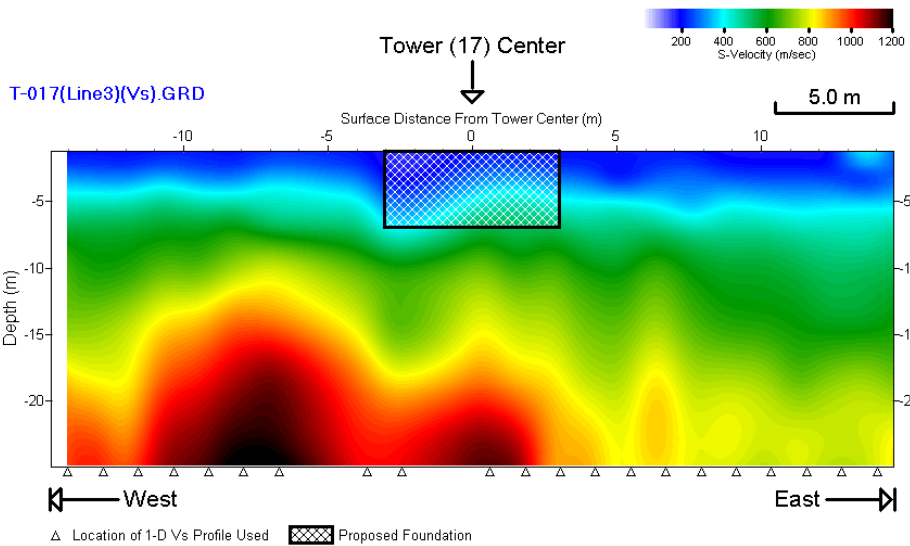
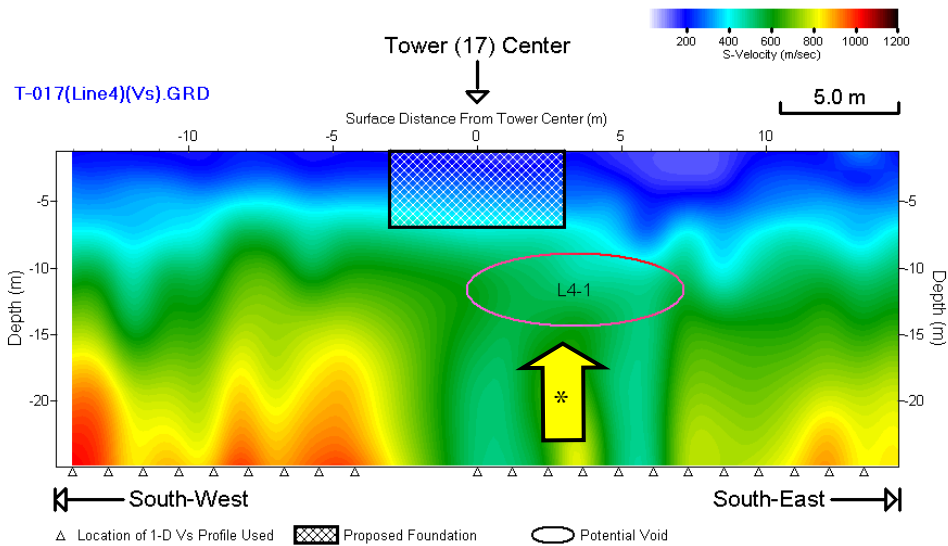
T-017

*Potential void or anomaly (see separate text file for coordinates)

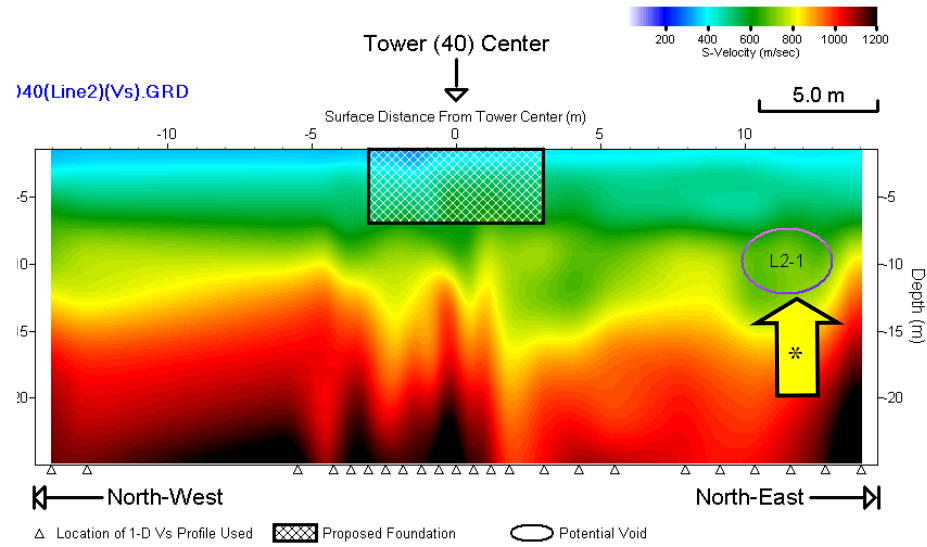
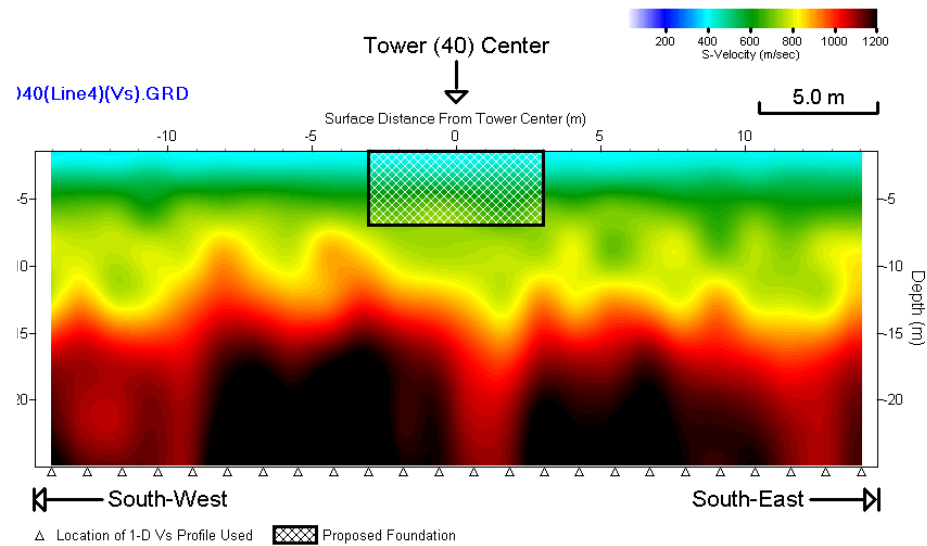
T-040

*Potential void (see separate text file for coordinates)

⁺ Potential void (SSA-1) identified is also correlated with the scattering feature observed in the corresponding part (within Line2) of the seismic line as illustrated on the left of SSA image.

*This is the approximate surface location of the anomaly interpreted on SSA and 2-D Vs images.

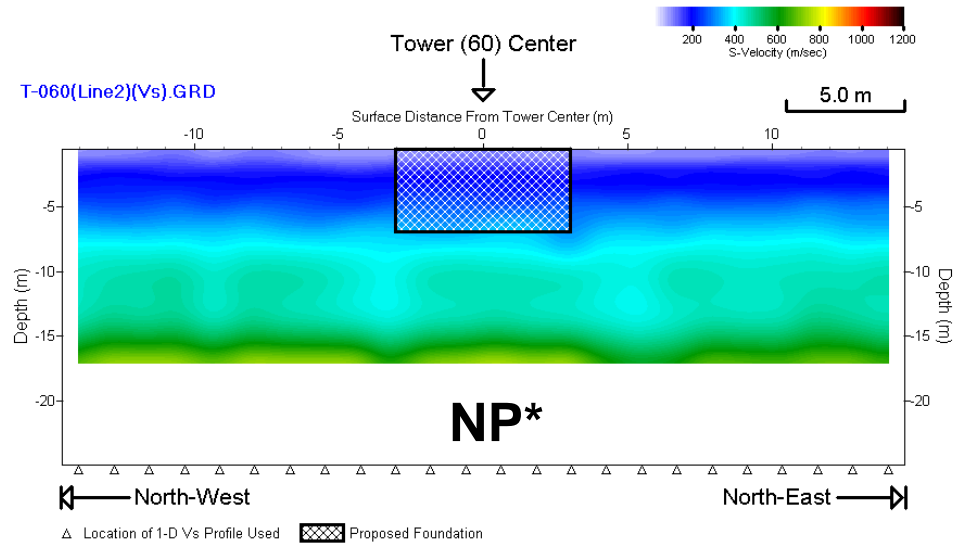
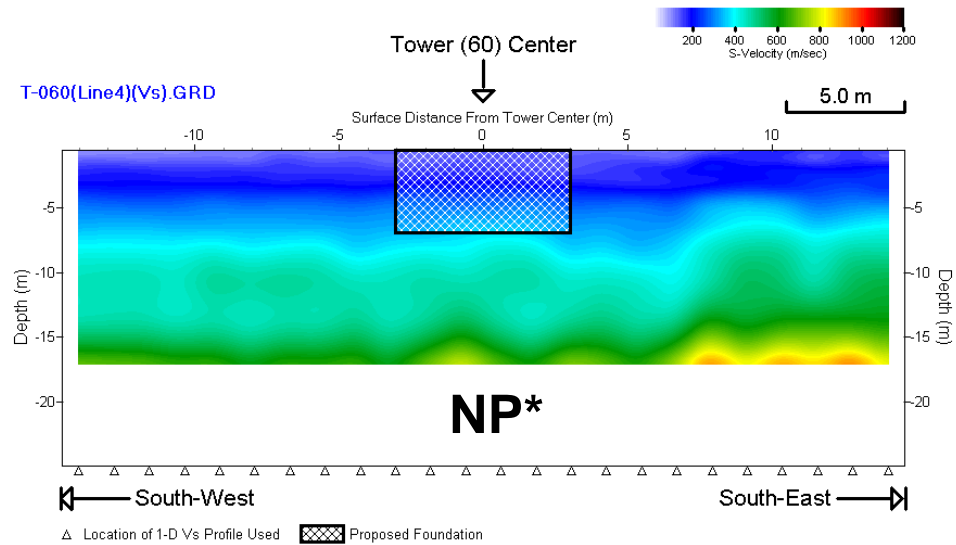
T-060

*Data not available due to insufficient penetration of surface waves

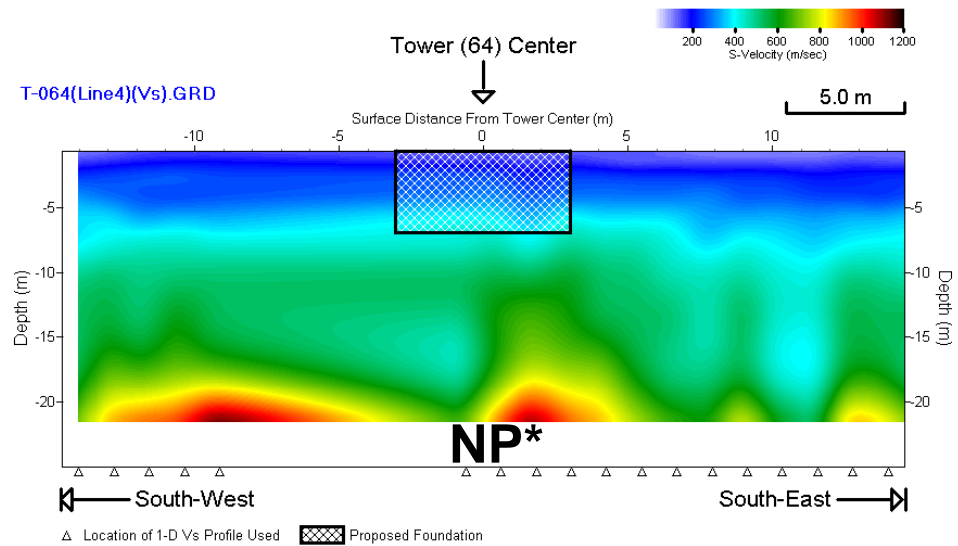
T-064

*Data not available due to insufficient penetration of surface waves

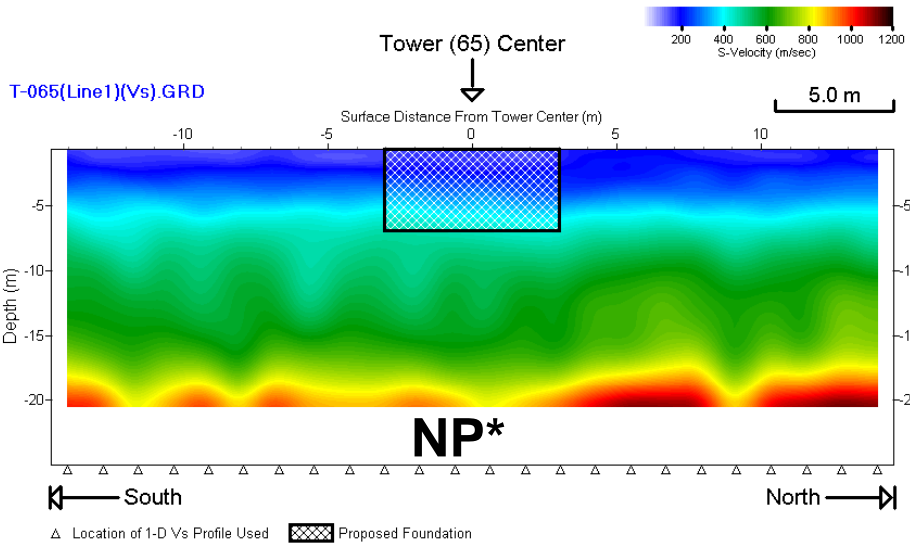
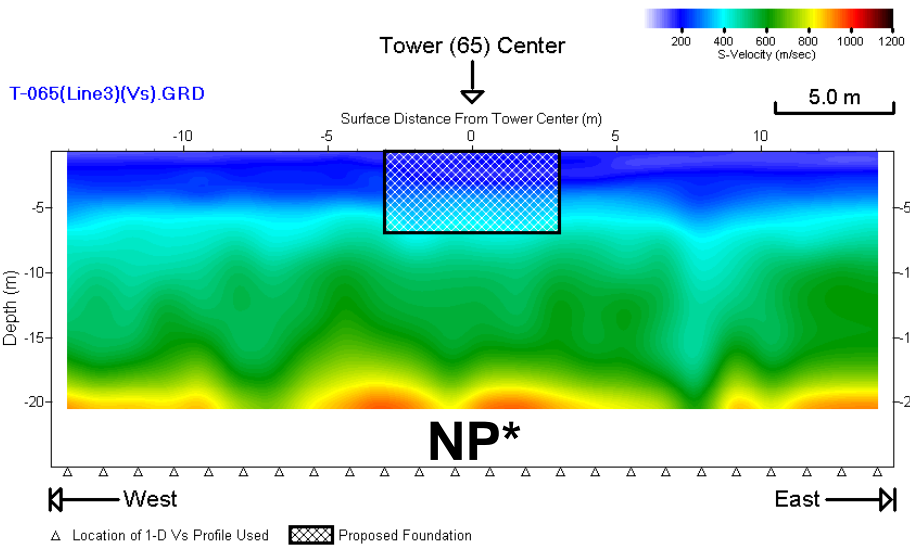
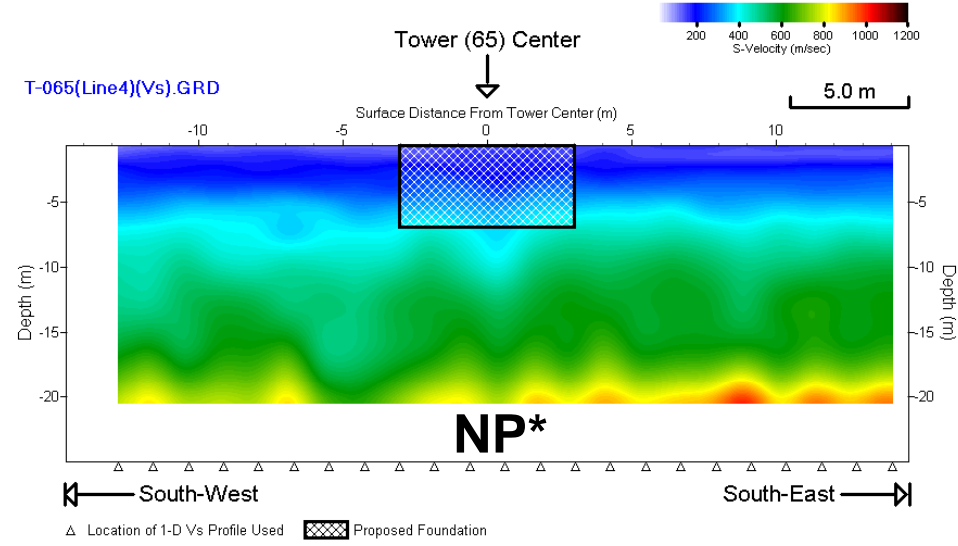
T-065

*Data not available due to insufficient penetration of surface waves **Potential void or anomaly (see separate text file for coordinates)

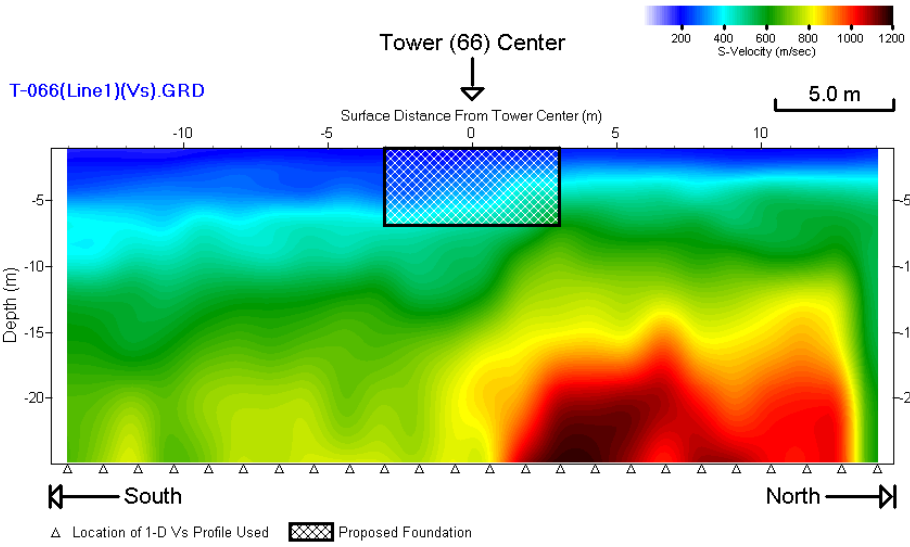
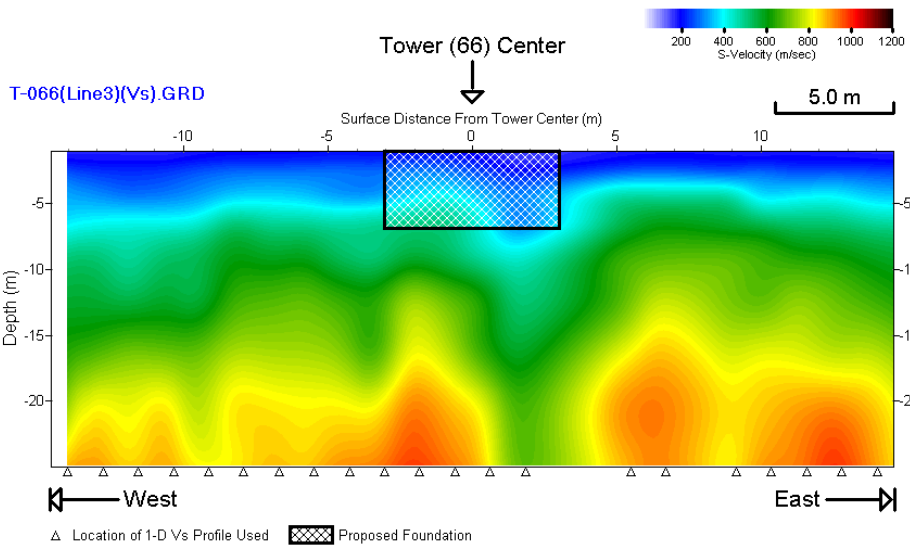
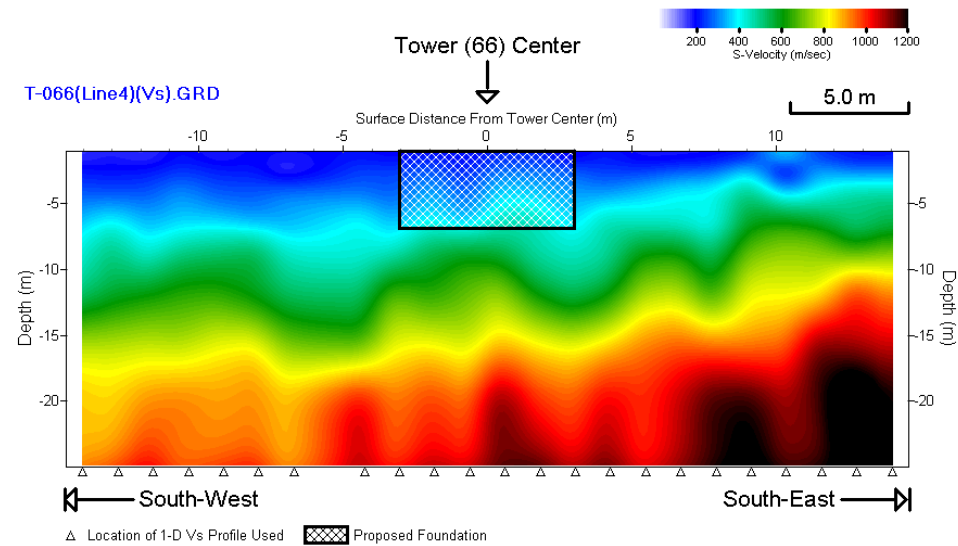
T-066

**Potential void or anomaly (see separate text file for coordinates)

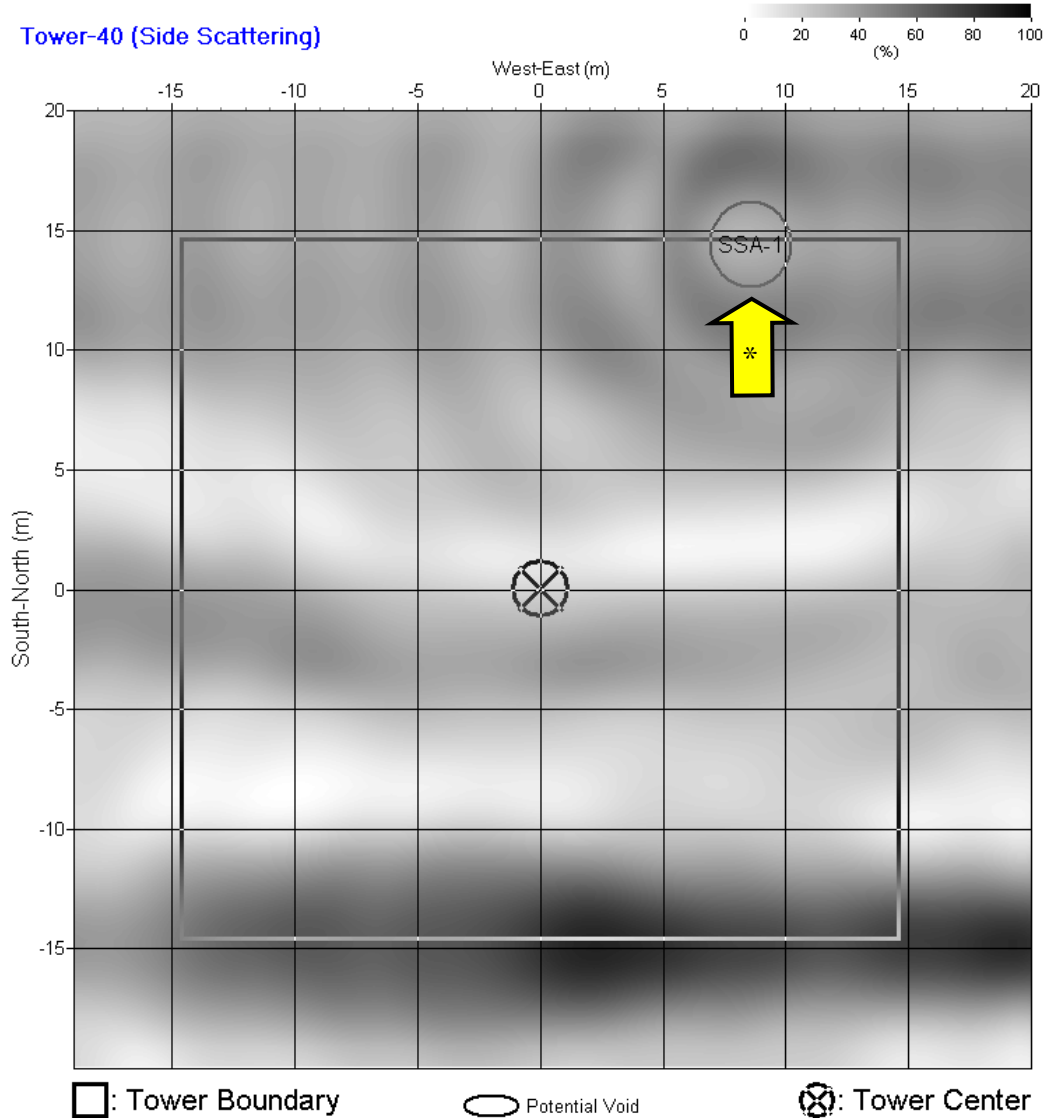
Tower-40 (Side Scattering)

Sensitive Depth Range: 1 – 10 m

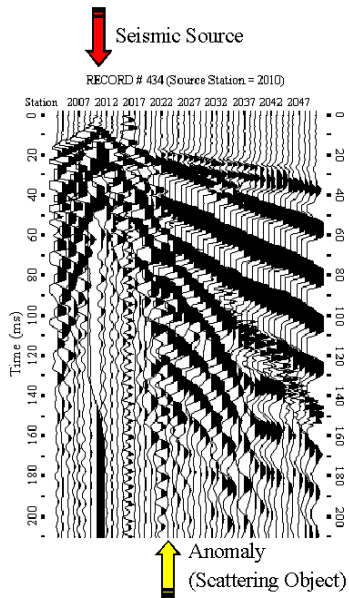
Shot Gather (Line 2)

*Potential void or anomaly (see separate text file for coordinates)
